Treatment of Salt Attack and Rising Damp in Heritage Buildings in Penang, Malaysia

*A Ghafar Ahmad and Haris Fadzilah Abdul Rahman

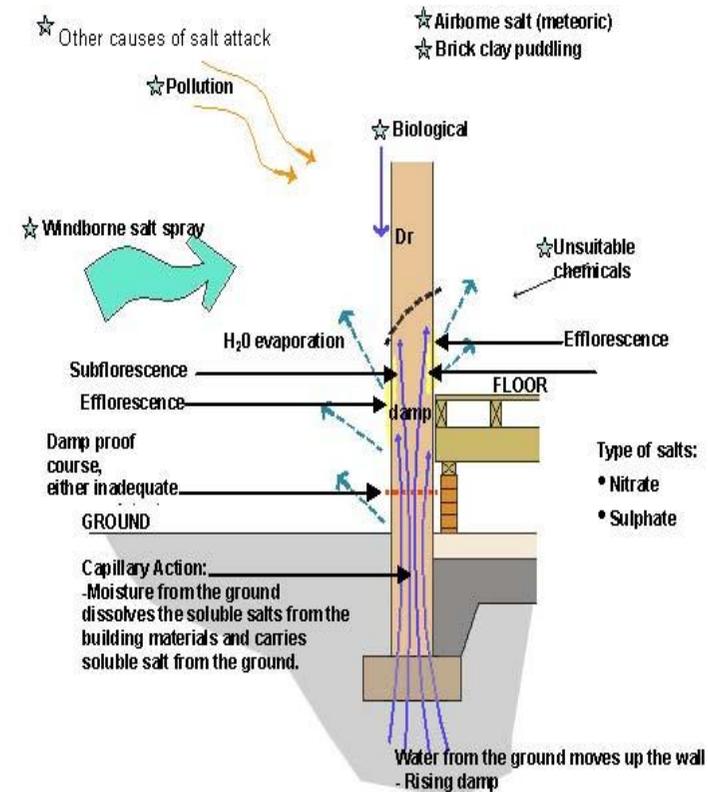
Figure 1. Causes of Salt Attack in Buildings

penetrates the surface and white powder is formed, this phenomenon is known as efflorescence and is harmless to the masonry (apart from creating an unsightly visual appearance). Salt may also attack by penetrating from below the surface; this is a more serious condition as the salt will become crystallised, a phenomenon known as subflorescence. Pressure from the growth of the crystallisation process will cause building materials to crumble, resulting in serious damage to the buildings (see Figure 1).

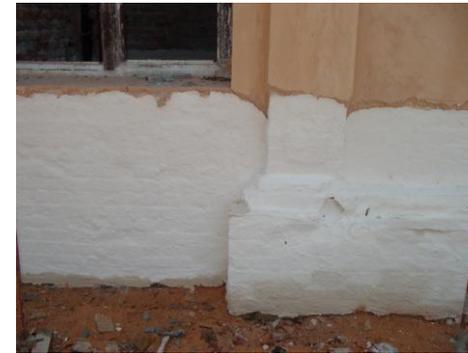
Figure 2. Treatment of Salt Desalination on Wall Surfaces Through the Process of Poulticing

The process of poulticing, also known as the Cocoon method, involves the application of a damp-absorbent material (pharmaceutical fibre mixed with distilled water) that dries out, drawing the salts from the material. After several weeks, the poultice is removed from the wall surface, taking the salts with it. The process is repeated as often as necessary to reduce the salt concentration to an acceptable level.

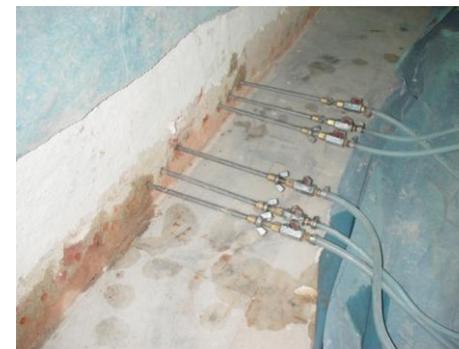
Figure 3. Treatment of a Course of Damp-proofing Through Chemical Injection

The injection of a chemical damp-proof course is the cheapest and easiest way to provide barrier in masonry walls to prevent rising damp. The treatment has to be applied prior to the treatment of salt attack. Chemical injection is carried out by drilling into both sides of the affected walls. The drilling is usually carried out at intervals along the wall at about 6 inches from the floor to a particular depth (depending on wall thickness). A silicone-based chemical is then injected either by using gravity flow or pumps until it is saturated and forms a moisture barrier that later prevents any water or dampness from moving upward in the masonry walls.
