## **Accessible Built Environment for the Elderly and Disabled in Malaysia: Hotels as Case Studies**

**Keywords:** Accessibility, Built environment, Access audit, Disabled, Hotel

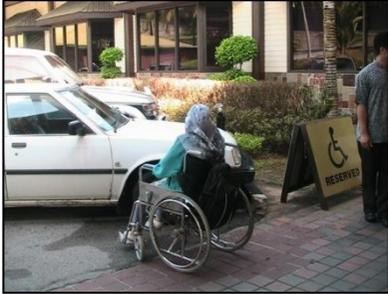
<p data-bbox="443 759 904 810">Figure 2. Accessible parking provided for the disabled with mobile signage.</p>	<p data-bbox="954 411 1126 432"><b>Wheelchair User</b></p> <ul data-bbox="954 475 1357 616" style="list-style-type: none"> <li>- Mobile signage for parking.</li> <li>- It is visible, but because it can be moved, the parking might be taken by other people.</li> </ul>	<ul data-bbox="1424 411 1888 464" style="list-style-type: none"> <li>- Fixed standing signage to indicate accessible parking is recommended.</li> </ul>

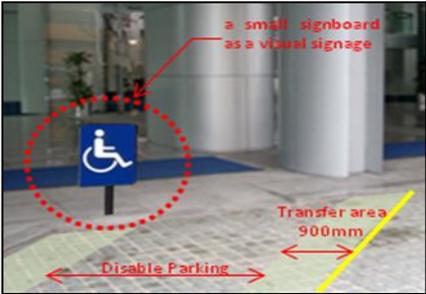
<p data-bbox="1440 783 1872 831">Figure 3. Example of small signboard to indicate accessibility for disabled parking.</p>

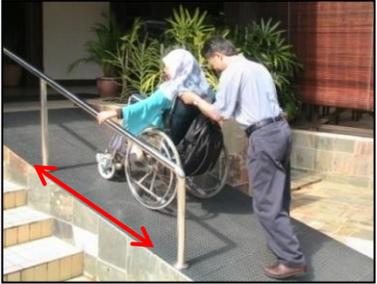
<p data-bbox="450 762 920 807">Figure 4: The steep ramp is not easy to use for wheelchair users.</p>	<p data-bbox="1003 411 1171 435"><b>Wheelchair User</b></p> <ul data-bbox="1003 475 1384 603" style="list-style-type: none"> <li>- Swimming pool area is difficult to be reach due to a steep ramp with a 1:7 gradient ratio. The wheelchair users require assistance to reach the swimming pool areas.</li> </ul> <p data-bbox="1003 643 1167 667"><b>Vision Impaired</b></p> <ul data-bbox="1003 707 1384 754" style="list-style-type: none"> <li>- Tactile warning surface is not provided at the edge of the steps.</li> </ul>	<ul data-bbox="1485 411 1883 659" style="list-style-type: none"> <li>- Existing steep ramp should be adjusted to 1:12 gradient with railing on both sides and provided with a 100 mm kerb at the edging.</li> <li>- To provide a tactile warning surface at the edge of the steps and at the beginning of the ramp for visually impaired people.</li> </ul>

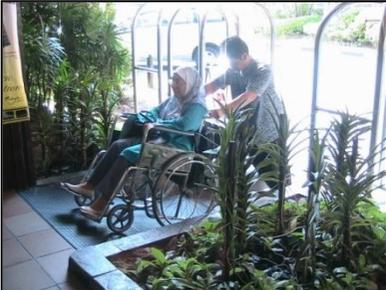
<p data-bbox="443 791 853 866">Figure 5. The ramp is too steep and disabled or elderly people often require assistance from others.</p>	<p data-bbox="902 411 1077 432"><b>Wheelchair User</b></p> <p data-bbox="902 475 1391 655">- Ramp at the entrance is not provided at an earlier stage of the design, the current ramp has a 1:10 gradient and is primarily used to bring luggage in and out of the hotel. A wheelchair user cannot wheel his/her wheelchair by himself/herself. Assistance is required in this area.</p> <p data-bbox="902 695 1070 716"><b>Vision Impaired</b></p> <p data-bbox="902 759 1391 863">The steps at the main entrance are not equipped with tactile warning surfaces at the edges or nosing with different coloured tiles to indicate edges for visually impaired people.</p>	<p data-bbox="1435 411 1888 486">- The ramp should be redesigned and reconstructed to achieve a gradient ratio of 1:12.</p>

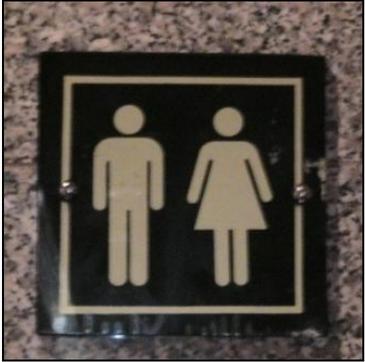
<p data-bbox="434 855 786 903">Figure 7. Signage for the disabled toilet is not included.</p>	<p data-bbox="857 411 1037 432"><b>Wheelchair users</b></p> <ul style="list-style-type: none"> <li data-bbox="857 475 1319 523">- Located at the lobby area. No signage for the disabled.</li> </ul> <p data-bbox="857 564 999 585">a) Male toilet</p> <ul style="list-style-type: none"> <li data-bbox="857 628 1319 783">- Male toilet is accessible. Space is large enough to manoeuvre. The size is acceptable. There is railing installed and accessible to the urinal. An appropriate washbasin height with a 600 mm door clearance is provided.</li> </ul>	<ul style="list-style-type: none"> <li data-bbox="1406 411 1895 491">- One unit for PWDs in the male toilet and female toilet, each near the restaurant, is proposed.</li> <li data-bbox="1406 528 1895 603">- Install tactile warning surfaces at the entrance of the wheelchair and attach signage for the disabled.</li> </ul>

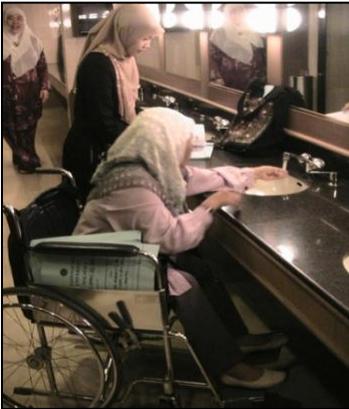
<p>b) Female toilet</p> <ul style="list-style-type: none"> <li>- The female toilet is accessible, but railing is not provided inside of the toilet area. The sink counter is acceptable and is accessible to the water tap. The hair dryer is accessible except that the tissue paper discharger to wipe the hands is not accessible.</li> </ul> <p><b>Vision Impaired</b></p> <ul style="list-style-type: none"> <li>- The label for gender is not embossed. This creates difficulties for visually impaired people to identify the toilet.</li> </ul>

- The signage should be able to be identified by the visually impaired people whether it is deeply embossed or engraved, or the signage should include Braille for easy identification.

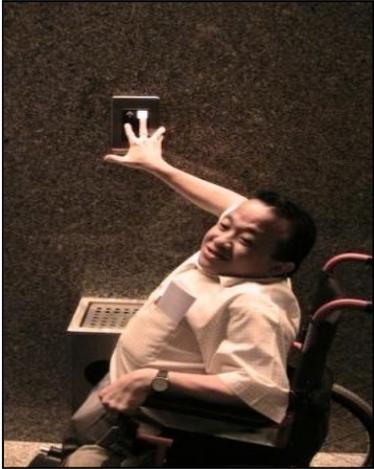
<p data-bbox="846 411 1016 434"><b>Wheelchair User</b></p> <ul style="list-style-type: none"> <li data-bbox="846 475 1323 549">- The buttons are accessible by wheelchair users. The call button is 1200 mm from the floor level.</li> <li data-bbox="846 590 1323 663">- Handrails mounted on three sides of the lift at a height of 800 mm from the floor level with a 40-mm diameter.</li> </ul> <p data-bbox="846 705 1016 727"><b>Vision Impaired</b></p> <ul style="list-style-type: none"> <li data-bbox="846 737 1189 759">- Four talking lifts are provided.</li> <li data-bbox="846 801 1323 849">- Braille for the blind is not provided but it is embossed.</li> <li data-bbox="846 890 1323 938">- No tactile warning surface installed in front of the lifts.</li> <li data-bbox="846 979 1323 1027">- Control panel is not installed with Braille (Height = 800 mm)</li> </ul>	<ul style="list-style-type: none"> <li data-bbox="1384 411 1892 485">- A tactile warning surface and Braille should be provided in front of the lift and Braille for visually impaired people.</li> </ul>
