Preservation Strategies for Historic Timber Mosques: Structural Integrity Assessment on Masjid Jamek An Nur, Batu Pahat, Johor

Abstract: This study addresses the critical need for preservation strategies to protect the Masjid Jamek An Nur in Kampung Patah Pedang, Batu Pahat, Johor and similar timber mosques from decay and neglect. Utilising building checklist assessment (BCA) methodology, this study thoroughly documented the condition of the mosque and identified a significant array of timber defects, including cracks, insect attacks and rot. The findings revealed that 30 structural elements (17 columns and 13 roof beams) were compromised, underlining the vulnerability of the mosque to structural failures. Severe weathering contributed to the most critical defects, with cracks alone constituting 38.27% of the defects. Through ultrasonic pulse velocity (UPV) testing, an analysis of the modulus of elasticity (MoE) revealed further structural vulnerabilities. Specifically, decay-induced compromise was detected in 43.63% of the columns tested, whereas the other columns displayed robust MoE values, representing 21.35% of the total tested. Notably, all roof beams met or exceeded the min

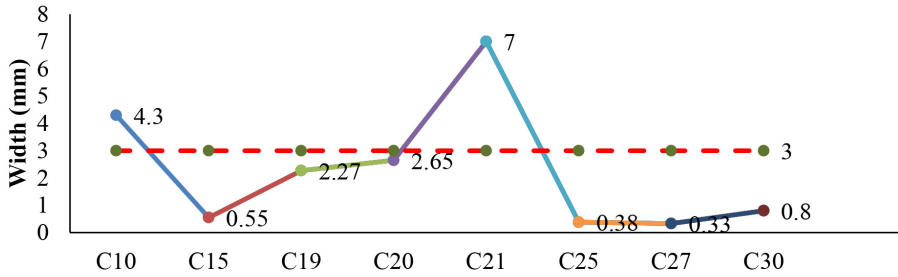
Figure 3. The defect detected in the mosque structure

Figure 3 illustrates the width of cracks at the mosque. The lines on the chart indicate that the highest width of cracks is at the C10 position, measuring 4.3 mm and C21 has a width of 7 mm, exceeding the allowable crack line permitted for timber building, which is 3 mm. The dark blue represents C10, yellow corresponds to C20, blue-black indicates C27, orange represents C15, maroon is for C30, grey corresponds to C19, green is C25 and finally, red represents the allowable crack based on the Australian Standard.

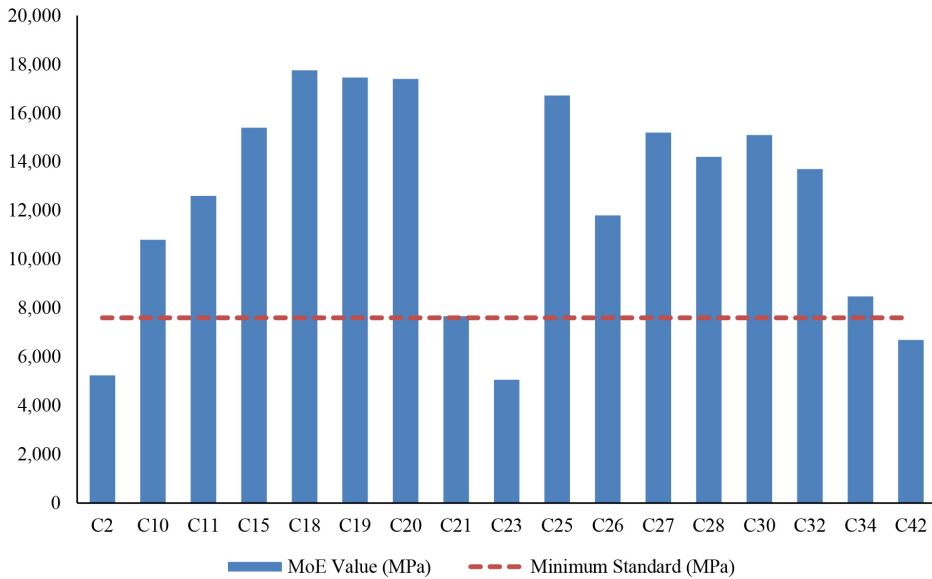
Figure 4. MoE distribution level for Masjid An Nur columns relative to SG4 minimum standard benchmarks

Figure 4 shows the UPV test results for the column structure at Masjid An Nur. The delivery method used in conducting this test is the direct method. The minimum level of MoE based on the Malaysian Standard (MS 544-2:2017) for SG4 is 7,600 MPa. Based on the results obtained, there are three columns that are in a weak condition. It is because these columns did not exceed the minimum level of SG4 which is C23 (5,058 MPa), C2 (5,239 MPa) and C42 (6,692 MPa) and column C23 recorded the lowest among others. Next, column C21 exceeded the MoE minimum level with 7,668 MPa. In contrast, column C18 recorded the highest integrity at 17,754 MPa, followed by C19 (17,456 MPa) and C25 (16,721 MPa). Most remaining columns displayed robust MoE values ranging from 10,000 to 16,000 MPa. Specifically, it identifies that while most elements are “Good”, three columns (C2, C23 and C42) are “Weak” because they fell below the 7,600 MPa threshold.

The analysis identified three columns at Masjid An Nur as compromised, failing to meet the minimum MoE threshold of 7,600 MPa stipulated by the Malaysian Standard (MS 544-2:2017). The lowest MoE readings were 5,058 MPa, 5,240 MPa and 6,691 MPa for columns C23, C2 and C42, respectively – all of which exhibited decay. Structural height was also found to affect the timber's strength, with columns at higher elevations being more vulnerable.

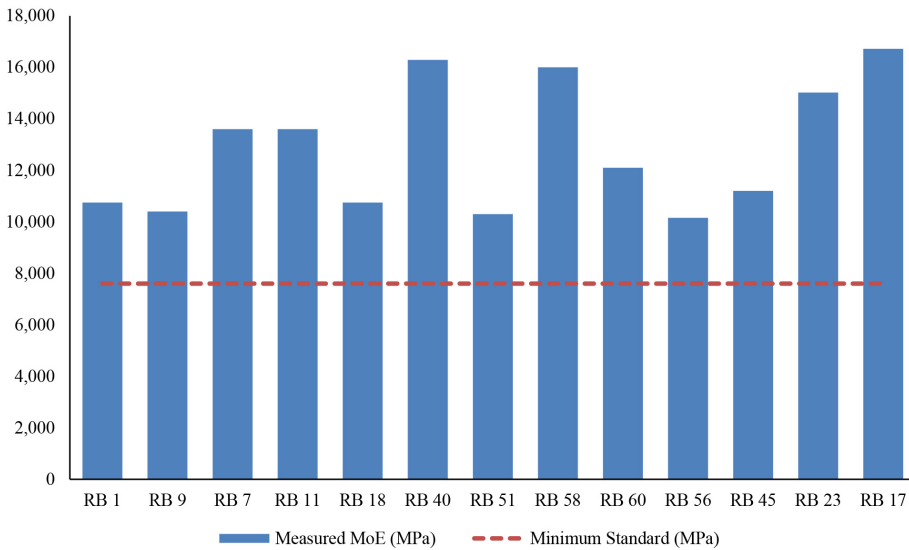
Figure 5. Comparative analysis of roof beam MoE results identifying consistent structural integrity compliance

Figure 5 shows the UPV test results for the roof beam structure at Masjid An Nur. For the roof beam, the delivery method for the UPV test is indirect method. Based on Figure 8, it was found that all roof beams passed the minimum MoE which is 7,600 MPa and are in a good condition. The roof beam that has the highest MoE value is RB 17 which is 16,721 MPa followed by RB 40 which is 16,287 MPa. Next, the third highest value is 16,002 Mpa which is RB 58 and followed by RB 23 with a MoE value of 15,021 MPa. The roof beams that obtain MoE values in the range of 10,200 Mpa to 13,600 MPa are RB 1, RB 9, RB 7, RB 11, RB 18 and RB 51. Lastly, RB 56 recorded the lowest MoE value with 10,156 Mpa.
