Protection Works Against Wave Attacks in the Haor Areas of Bangladesh: Analysis of Sustainability

Abstract: Haor is the local name of the saucer-shaped, naturally depressed areas of Bangladesh. There are 414 haors in the northeast region that comprise approximately 17% of the country. These areas are submerged under deep water from July to November due to the overflow of rivers and heavy rainfall, causing them to appear like seas with erosive waves. Recently, the wave attack has drastically increased because of de-plantation and changing cropping patterns to allow for more agricultural production. The local people, government and Non-Government Organisations (NGOs) have tried many techniques to protect life and property against wave attacks. A cost comparison shows that Cement Concrete (CC) blocks over geotextile on the slope embankment is a cost-effective, environment friendly and socially acceptable method to prevent loss of life and property. However, the design rules employed by the engineers are faulty because there is knowledge gap in the application of wave hydraulics among these professionals. As a result, damage frequently occurs and maintenance costs are increasing. This

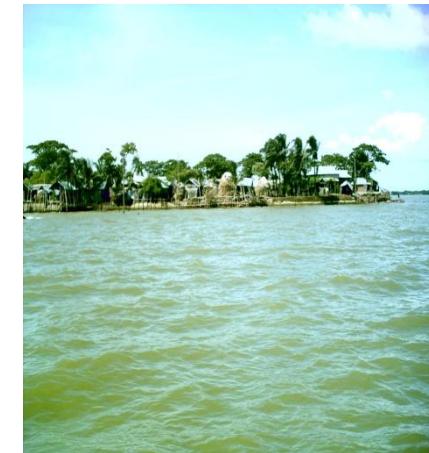
Figure 2. View of a village in the haor area during a monsoon

and heavy rainfall from July through November, these areas are submerged in 4 to 5 meter of water and become similar to with erosive waves (see Figure 2). During dry season (December to April), the water is completely drained from the area by gravity and the area returns to fertile land for crop production. The people of this area are mostly poor farmers and fishermen and survive below the poverty level.

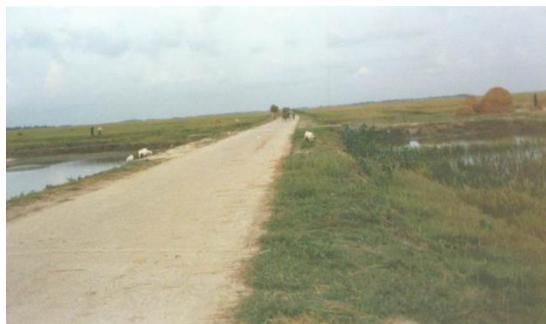
Figure 3. Submersible concrete road (low) dykes in the haor area to prevent early flash floods

Organisations (NGO) constructed submersible (low) dykes along the rivers and paddy fields to prevent early flash floods that occur in mid-May. These submersible dykes are approximately 1 meter in height from the surrounding lands and are located in deep water during a monsoon (see Figure 3). These dykes around the paddy field have been paved with concrete for road communication. Due to the construction of these submersible (low) dykes, the bumper production of crops has become possible. The living standard of the local people has greatly improved. However, this improvement is limited to the dry season and hardly extends past four to five months of the year.

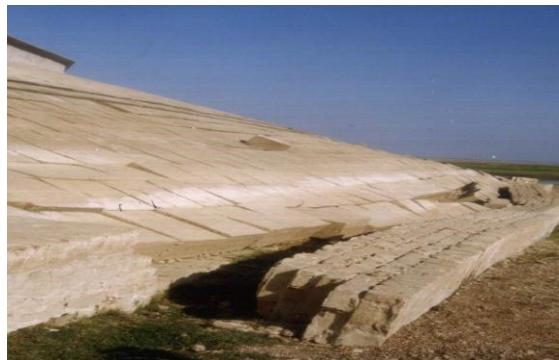
Figure 6. Brick toe wall collapsed (under water) and CC blocks slid down slope (view in dry season, first damage)

The first damage to this new structure occurred six months after the construction in the 1999 flood, which included the entire collapse of the brick toe wall and movement of the CC blocks down the slope (see Figure 6). In the following dry season, the brick toe wall was replaced

by a CC beam that was casted below the ground level and anchored to a level that matched the embankment slope of 1:2 (see Figure 7).

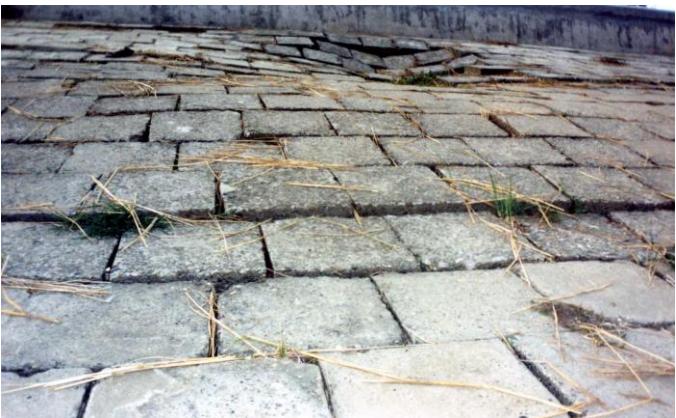
Figure 8. A view of the CC block settlement in the upper part of the slope during the 2003 flood (second damage)

The second set of damages occurred during the 2003 monsoon in which the CC blocks were compromised at five places because of strong wind waves. However, the damages were not severe and regular repair work restored the wall (see Figure 8).

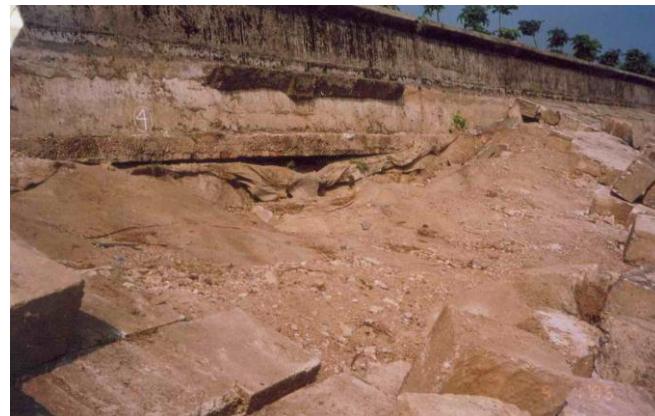
Figure 9. One of the breaches at the bottom of the guard wall approximately at the middle of the embankment

The third damage occurred in August 2004 and is considered the most severe. In this storm, the water level exceeded previous maximum levels and was an event with a 120-year re-occurrence pattern. The water level was only 0.7 meter below the embankment crest level. There was continuous rainfall for seven days in the area and the run-off at the crest accumulated at the bottom of the guard wall due to a cross slope toward the wall. Breaches were created at four places along the length of the embankment due to the wave thrust at the foot of the

guard wall and flood water rushed toward the countryside areas through the holes. Sand bags were dumped at these locations to minimise gushing water (see Figure 9, 10, 11 and 12). All damage occurred during a single storm on 17th August 2004. However, the toe wall was intact throughout the length of the embankment and blocks did not slide down the slope.

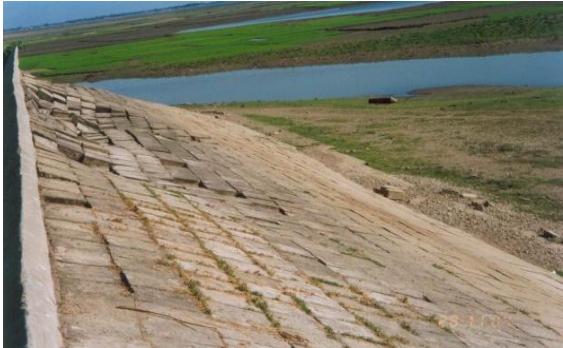
Figure 10. Settlement of CC-blocks the crest of the guard wall during storm wave during 17th August, 2004

The major damages occurred at the upper part of the embankment in the vicinity of the vertical guard wall at regular, horizontal intervals (see Figure 10). Each major damage site showed a substantial subsidence of soil level under the geotextile. The covering revetment blocks caved in, following the subsidence areas. The decline in soil level corresponded to a virtual loss of the soil body up to 1 m^3 that formed a wedge-shaped cavity under the revetment. The bottom of the cavity was nearly horizontal and at the same depth as the foundation of the vertical guard wall.

Therefore, the main causes of the major damages of block settlement were due to locally improper compaction of the upper part of the embankment that led to the widespread settlement of the soil.

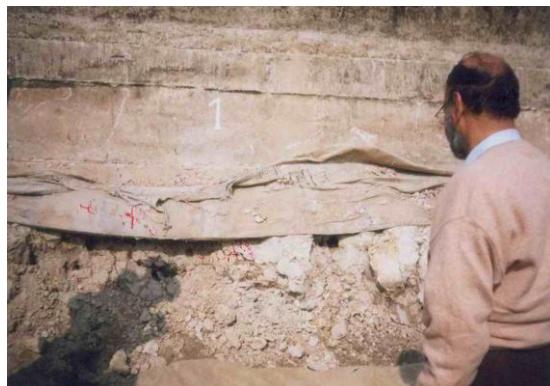
Figure 11. Cavities below geotextiles

The geotextile appeared to be evenly sunk with the soil level and was undisturbed and undamaged. However, the geotextile did not align with the transition with the guard wall and was not properly anchored and sealed. Erosion channels were found below the geotextile at those locations (see Figure 11).

Rain water infiltrated the ground and reached below the foundation of the guard wall, which created cavities and a channel. Because of this, the CC blocks revetment lost contact with the soil and arching occurred. These changes could not be seen from the surface and hence could not be checked during regular inspection work. During the extreme flood on 17 August 2004, the water level reached near to the foot of the guard wall. The soil became further saturated and the wave impact caused heavy loads of water that lead to a disastrous settlement of the soil over a large area.

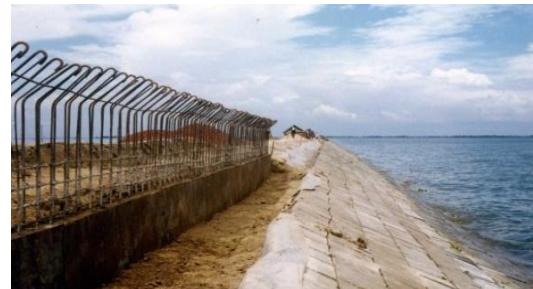
Figure 13. Construction of RCC guard wall with earth filling that was not compacted

Examination of the guard wall construction procedure revealed that the remaining soil mass was loosely filled up to the crest level without proper compaction (see Figure 13) under the assumption that the water level would seldom reach that height.

- the purpose of saving lives and property of residents because of the resistant property of geotextile.
- (3) The construction of the protection infrastructure should be completed at a time before the next wave attack. Dependence on the natural process of soil compaction of embankment during the following monsoon and rehabilitation in the dry season is a serious lapse in the construction procedure, which increases maintenance cost.

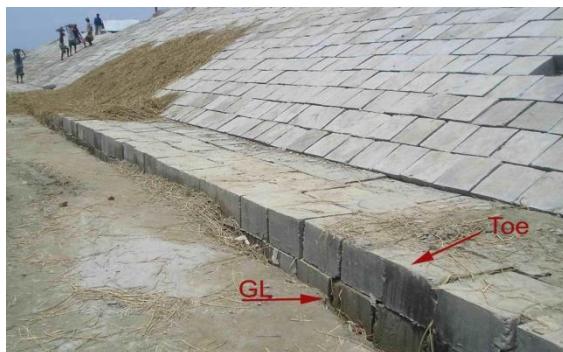
Figure 17. Toe structure above ground level

compaction was not followed. Instead, geotextile was laid over the slope after nominal dressing. The slope was steeper than the design slope of 1:2. Because the CC blocks were in double layers, the toe structure was not buried below the ground level and was laid above the ground surface (see Figure 17).

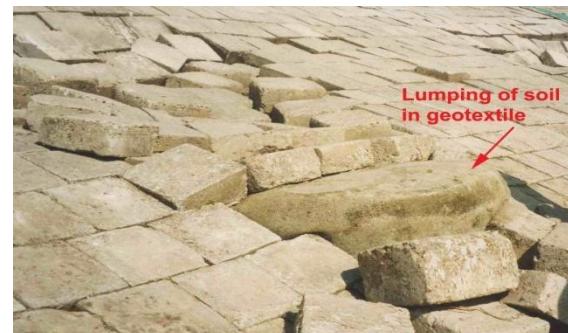
Figure 18. Lumping of soil in the geotextile due to wave suction

locations with each covering an area between 2 and 5 m² in a saucer shape. The failure points were located near the middle of the slope surface (see Figure 16). It was reported by the villagers that during wave attack, muddy water emerged from the damaged points and the CC blocks were removed from those affected points. The earth underneath the blocks had shifted and lumped in the geotextile (see Figure 18). Geotextile was also found wrapped, bulged and distorted. In the open condition, the overlapping of joints was found to be inadequate.

wave height and wave period). The geotextile was appropriately installed without any soil analysis and construction was completed with inadequate compaction of the soil. Even with all these lapses, the embankment sustained the wave attack with severe damages.
