Indoor Air Quality in Adaptively Reused Heritage Buildings at a UNESCO World Heritage Site, Penang, Malaysia

Abstract: This study investigated the Indoor Air Quality (IAQ) level in heritage buildings that have been adaptively reused as office buildings. These buildings are located within the vicinity of the UNESCO World Heritage Site in George Town, Penang. The aim of this study was to determine the IAQ level in the designated buildings using thermal monitoring and chemical and microbial tests. Mixed methods were used in this cross-sectional study to achieve the objectives. The IAQ tests variables were the temperature, relative humidity, air velocity, airborne pollutants (Particle Matter 10 [PM₁₀], carbon monoxide, carbon dioxide and formaldehyde), total bacteria count and total fungal count. These variables were adopted from the Industry Code of Practice on Indoor Air Quality, Department of Occupational Health Malaysia and the Malaysian Green Building Index–Non Residential Existing Building (NREB) rating tool. The measurements show that the IAQ level in the identified buildings was unacceptable within the standards stipulated. Dampness stains and mould were present in all buildin

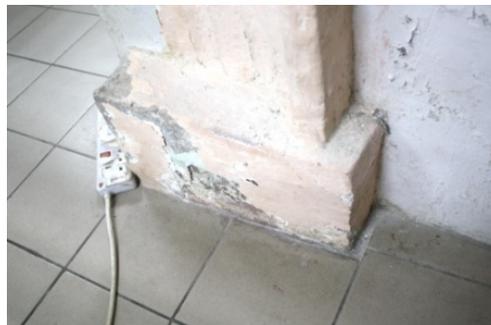
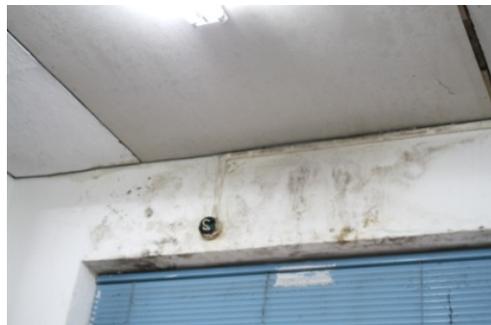
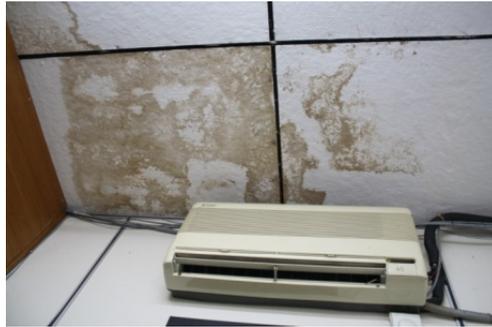
Figure 3. Dampness on Building Fabric

The UNESCO World Heritage Site in George Town is located on the north end of Penang Island. Its location near the sea affects the ground water level and salinity. These conditions put the heritage buildings at risk of deterioration due to moisture problems. Moisture is the greatest enemy of buildings because it can cause dampness in the building envelope and internal walls. Based on the site observations, dampness was prevalent in the identified buildings (Figure 3). Dampness triggers the growth of fungi and other microbial agents that can degrade air quality. Fungal stains were also observed on the building fabric of the identified buildings (Figure 4).

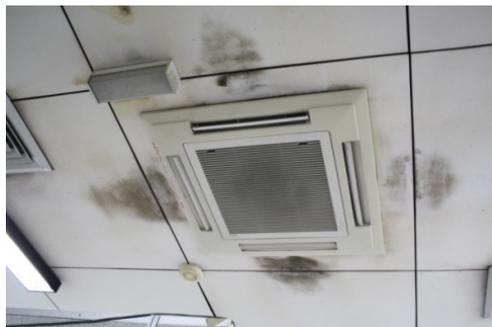
Figure 4. Visible Fungal Stains

The peeling and crumbled paint also indicated fungal activity. Fungi are highly erosive and they can live under low water activity (a_w) conditions. They are strongly enzymatic and can cause the decay of plaster, lime, paint, stone and mortar in the exterior and interior of a building. They also degrade the organic binders in paints, causing the reduction and loss of paint layers (Sterflinger, 2010).

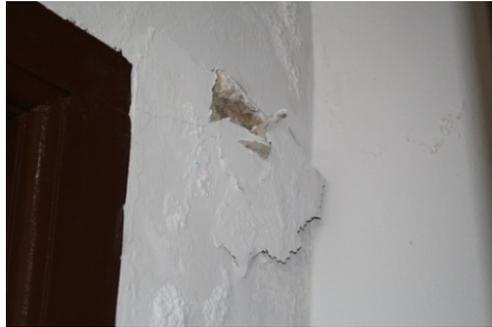
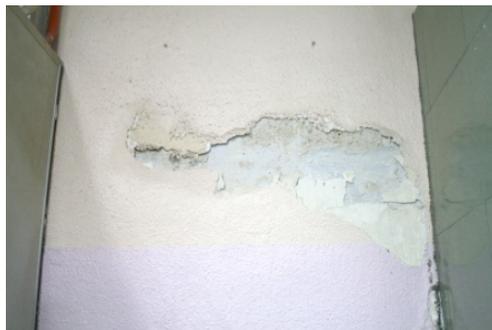
Figure 5. Peeling Paint

In this study, peeling paint was noticed in some of the buildings, particularly on the building columns (Figure 5).

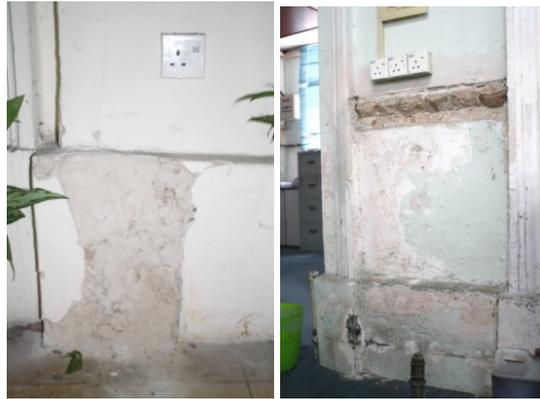
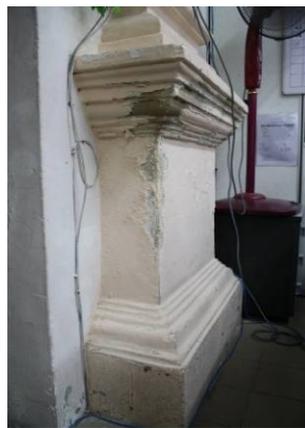
Figure 6. Salt Crystallisation on Building Fabrics

In addition to dampness and fungal spores, salt crystallisation also contributes to indoor air pollution. Hygroscopic salt, or salt weathering, is commonly related to moisture problems in buildings and it occurs when salt remains intact on a wall after the moisture has evaporated. After time, materials decay by fretting, crumbling and loss of the surface. In this study, salt weathering was observed in almost all of the identified buildings (Figure 6).

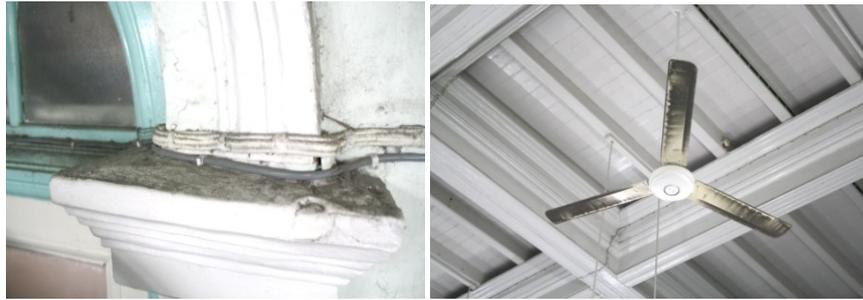
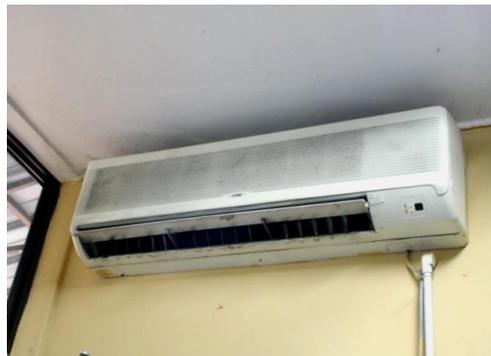
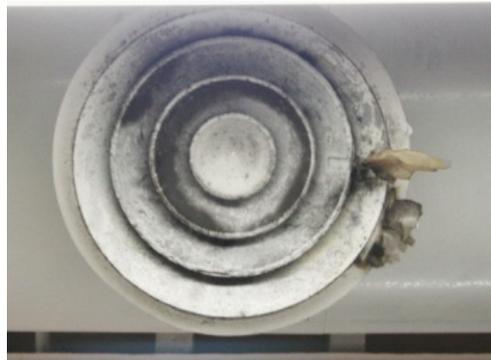
Figure 7. Accumulated Dust

Another visible pollutant discovered during site observation was dust. It was mostly accumulated in the mechanical ventilation system (air conditioner diffusers and fan blades), on the architectural ornaments such as cornices and mouldings and on open shelves (Figure 7). The classical architectural ornaments act as dust harvesters due to a lack of maintenance in each building. The amount of dust is based on the housekeeping practices in a building. Dust particles in damp spaces may contain harmful biological agents, particularly *Aspergillus* and gram-negative bacteria (Cabral, 2010).
