## **Accessible Built Environment for the Elderly and Disabled in Malaysia: Hotels as Case Studies**

**Keywords:** Accessibility, Built environment, Access audit, Disabled, Hotel

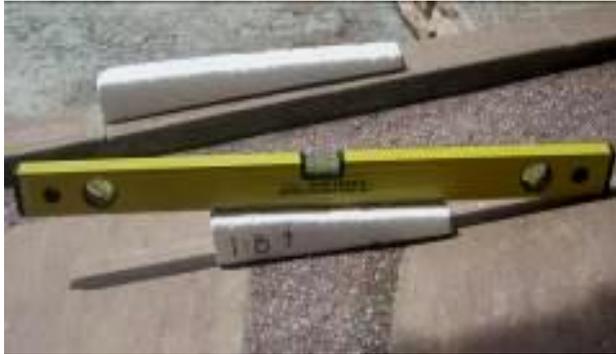
Figure 1. Using gradient model and levelling to measure the slope of the ramps  
Source: Research.
