Preservation Strategies for Historic Timber Mosques: Structural Integrity Assessment on Masjid Jamek An Nur, Batu Pahat, Johor

Abstract: This study addresses the critical need for preservation strategies to protect the Masjid Jamek An Nur in Kampung Patah Pedang, Batu Pahat, Johor and similar timber mosques from decay and neglect. Utilising building checklist assessment (BCA) methodology, this study thoroughly documented the condition of the mosque and identified a significant array of timber defects, including cracks, insect attacks and rot. The findings revealed that 30 structural elements (17 columns and 13 roof beams) were compromised, underlining the vulnerability of the mosque to structural failures. Severe weathering contributed to the most critical defects, with cracks alone constituting 38.27% of the defects. Through ultrasonic pulse velocity (UPV) testing, an analysis of the modulus of elasticity (MoE) revealed further structural vulnerabilities. Specifically, decay-induced compromise was detected in 43.63% of the columns tested, whereas the other columns displayed robust MoE values, representing 21.35% of the total tested. Notably, all roof beams met or exceeded the min

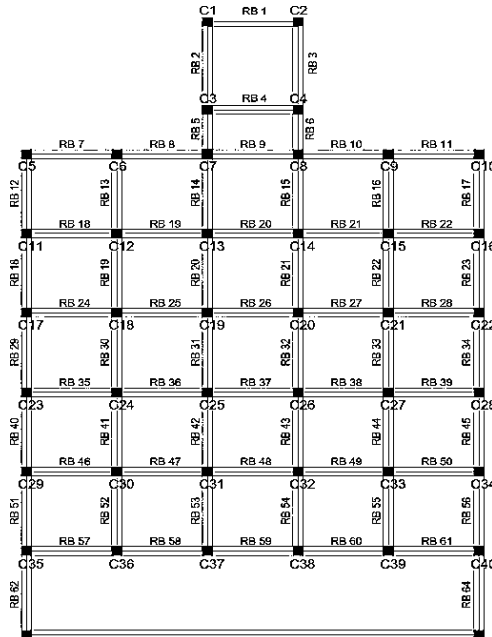
Figure 2. The column and roof beams position for UPV test at Masjid An Nur

the mosque's timber components. This layout is utilised to determine the positions of beams and columns in the mosque. The structural layout plan (as shown in Figure 2) provided the necessary directional indicators, using "C" for columns and "RB" for roof beams, to determine the exact testing positions.
